# Debris/Ice/TPS Assessment And Photographic Analysis For Shuttle Mission STS-42

March 1992

National Aeronautics and  
Space Administration

**Gregory N. Katnik**  
**NASA/Kennedy Space Center**

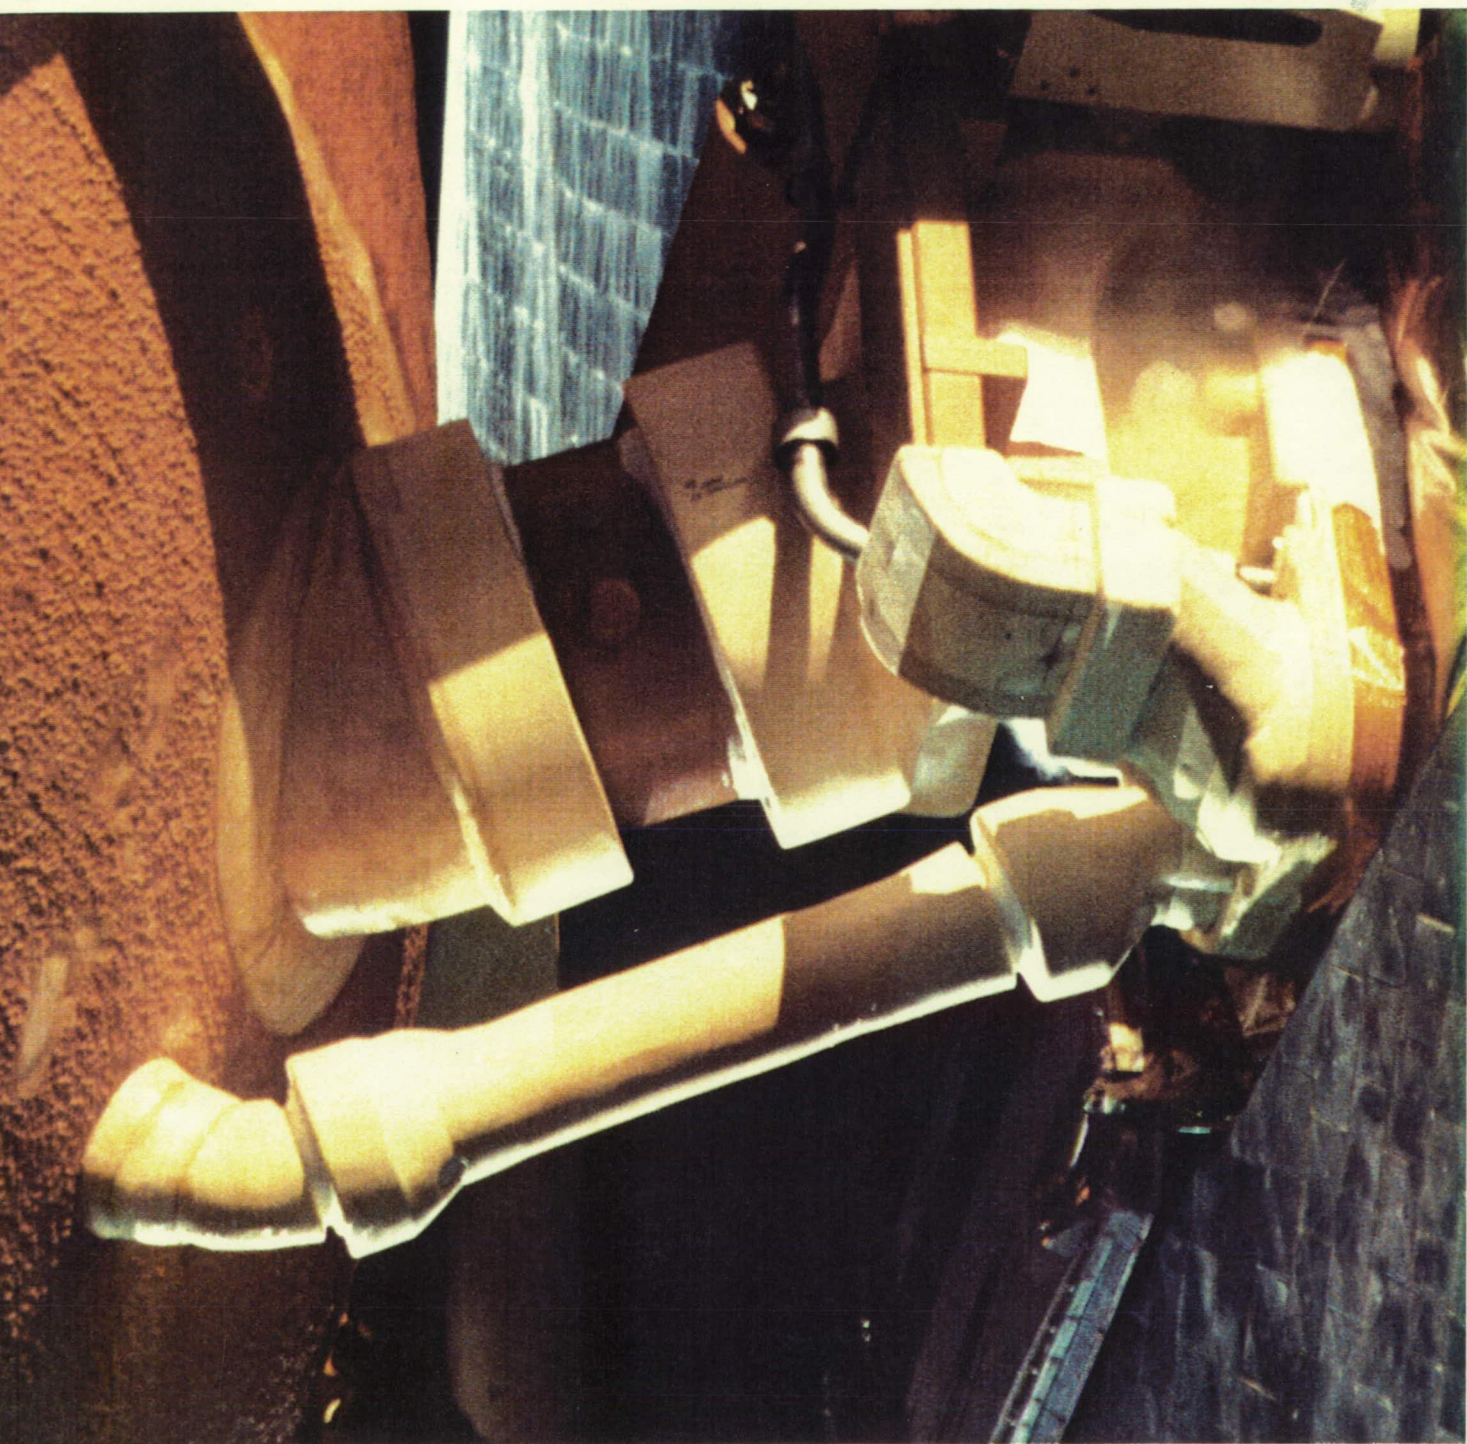
Overall view of the LH2 ET/ORB umbilical. There were no unusual vapors emanating from the umbilical nor any evidence of cryogenic drips. Ice/frost accumulations in the recirculation line bellows, on the burst disks, on the umbilical purge vents, and on the top side of the umbilical were typical.

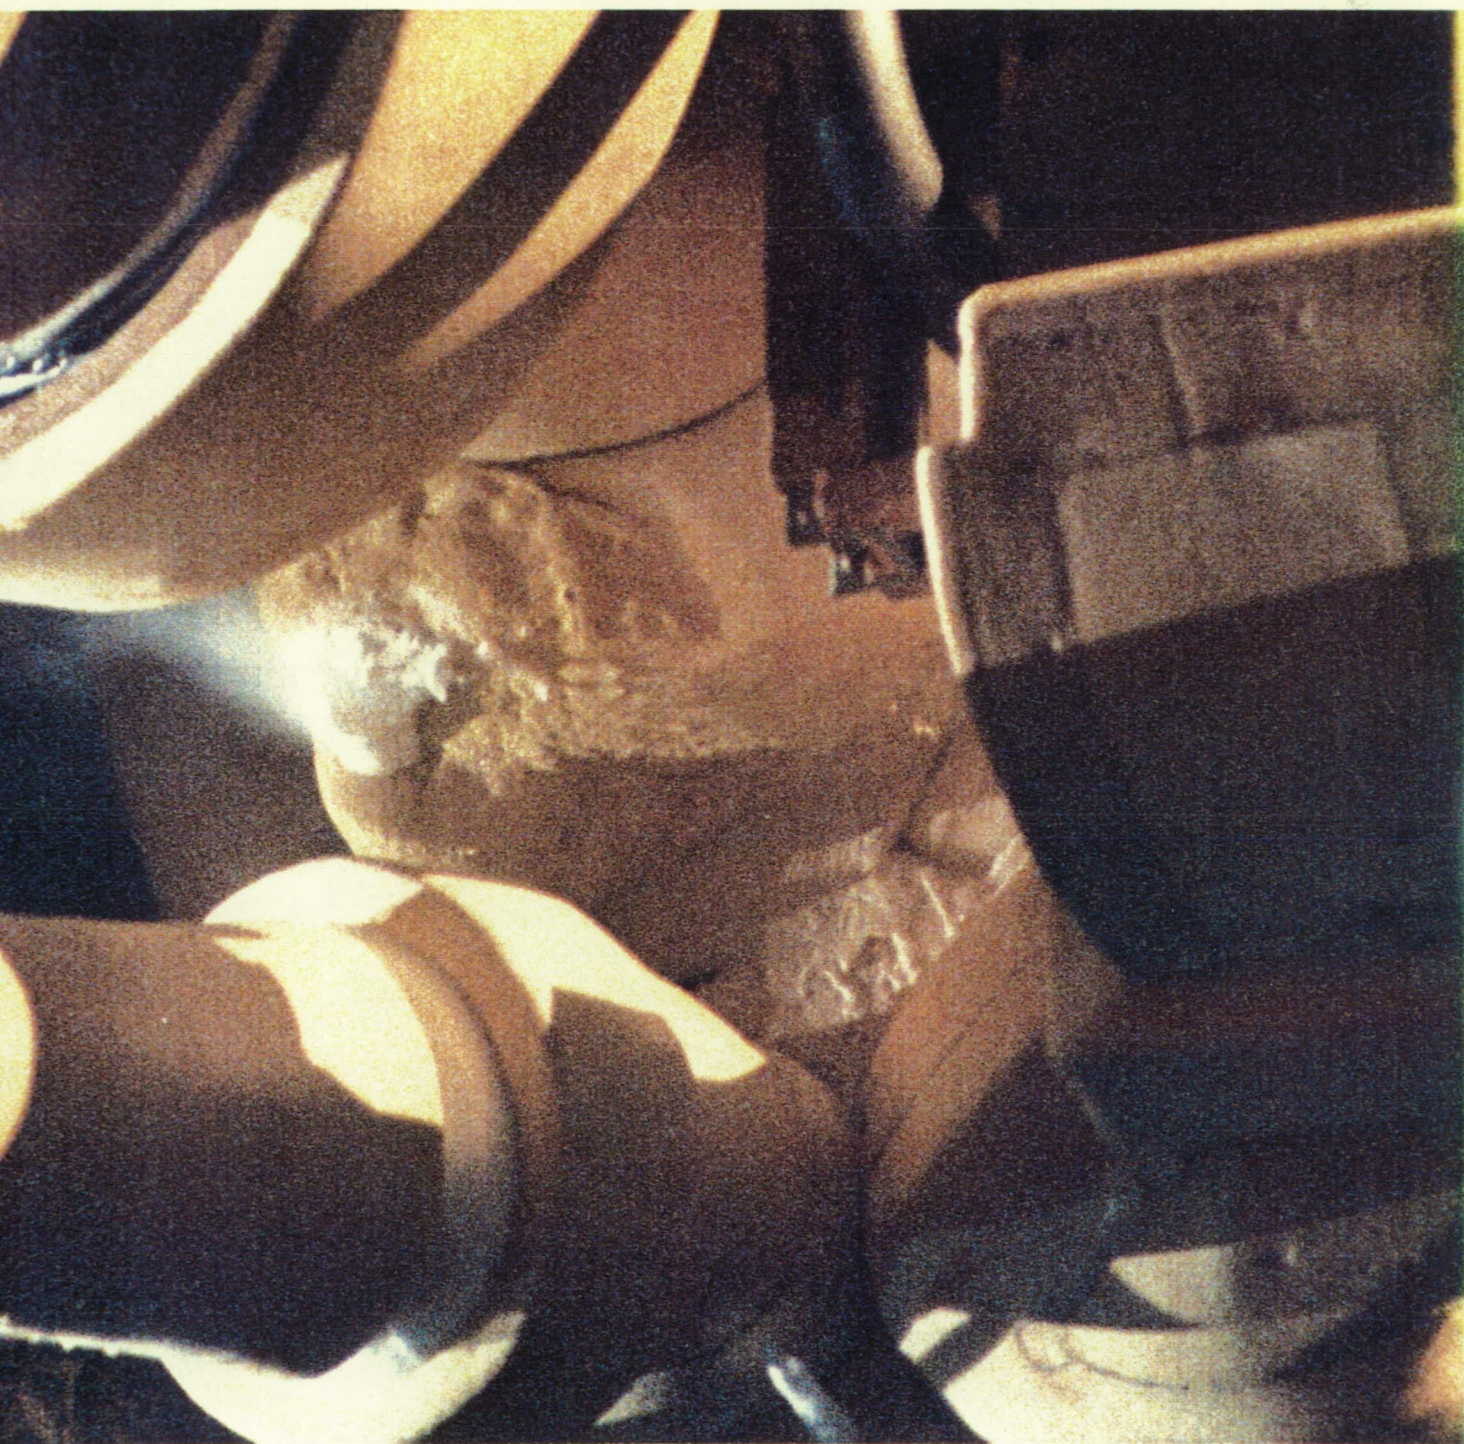
Ice/frost formations on the lower plate gap purge vent, the aft pyro canister purge vent, and in the LH2 recirculation line bellows were typical. The cable tray vent hole and 17-inch flapper valve actuator tool access port closeout exhibited no ice or frost accumulations.

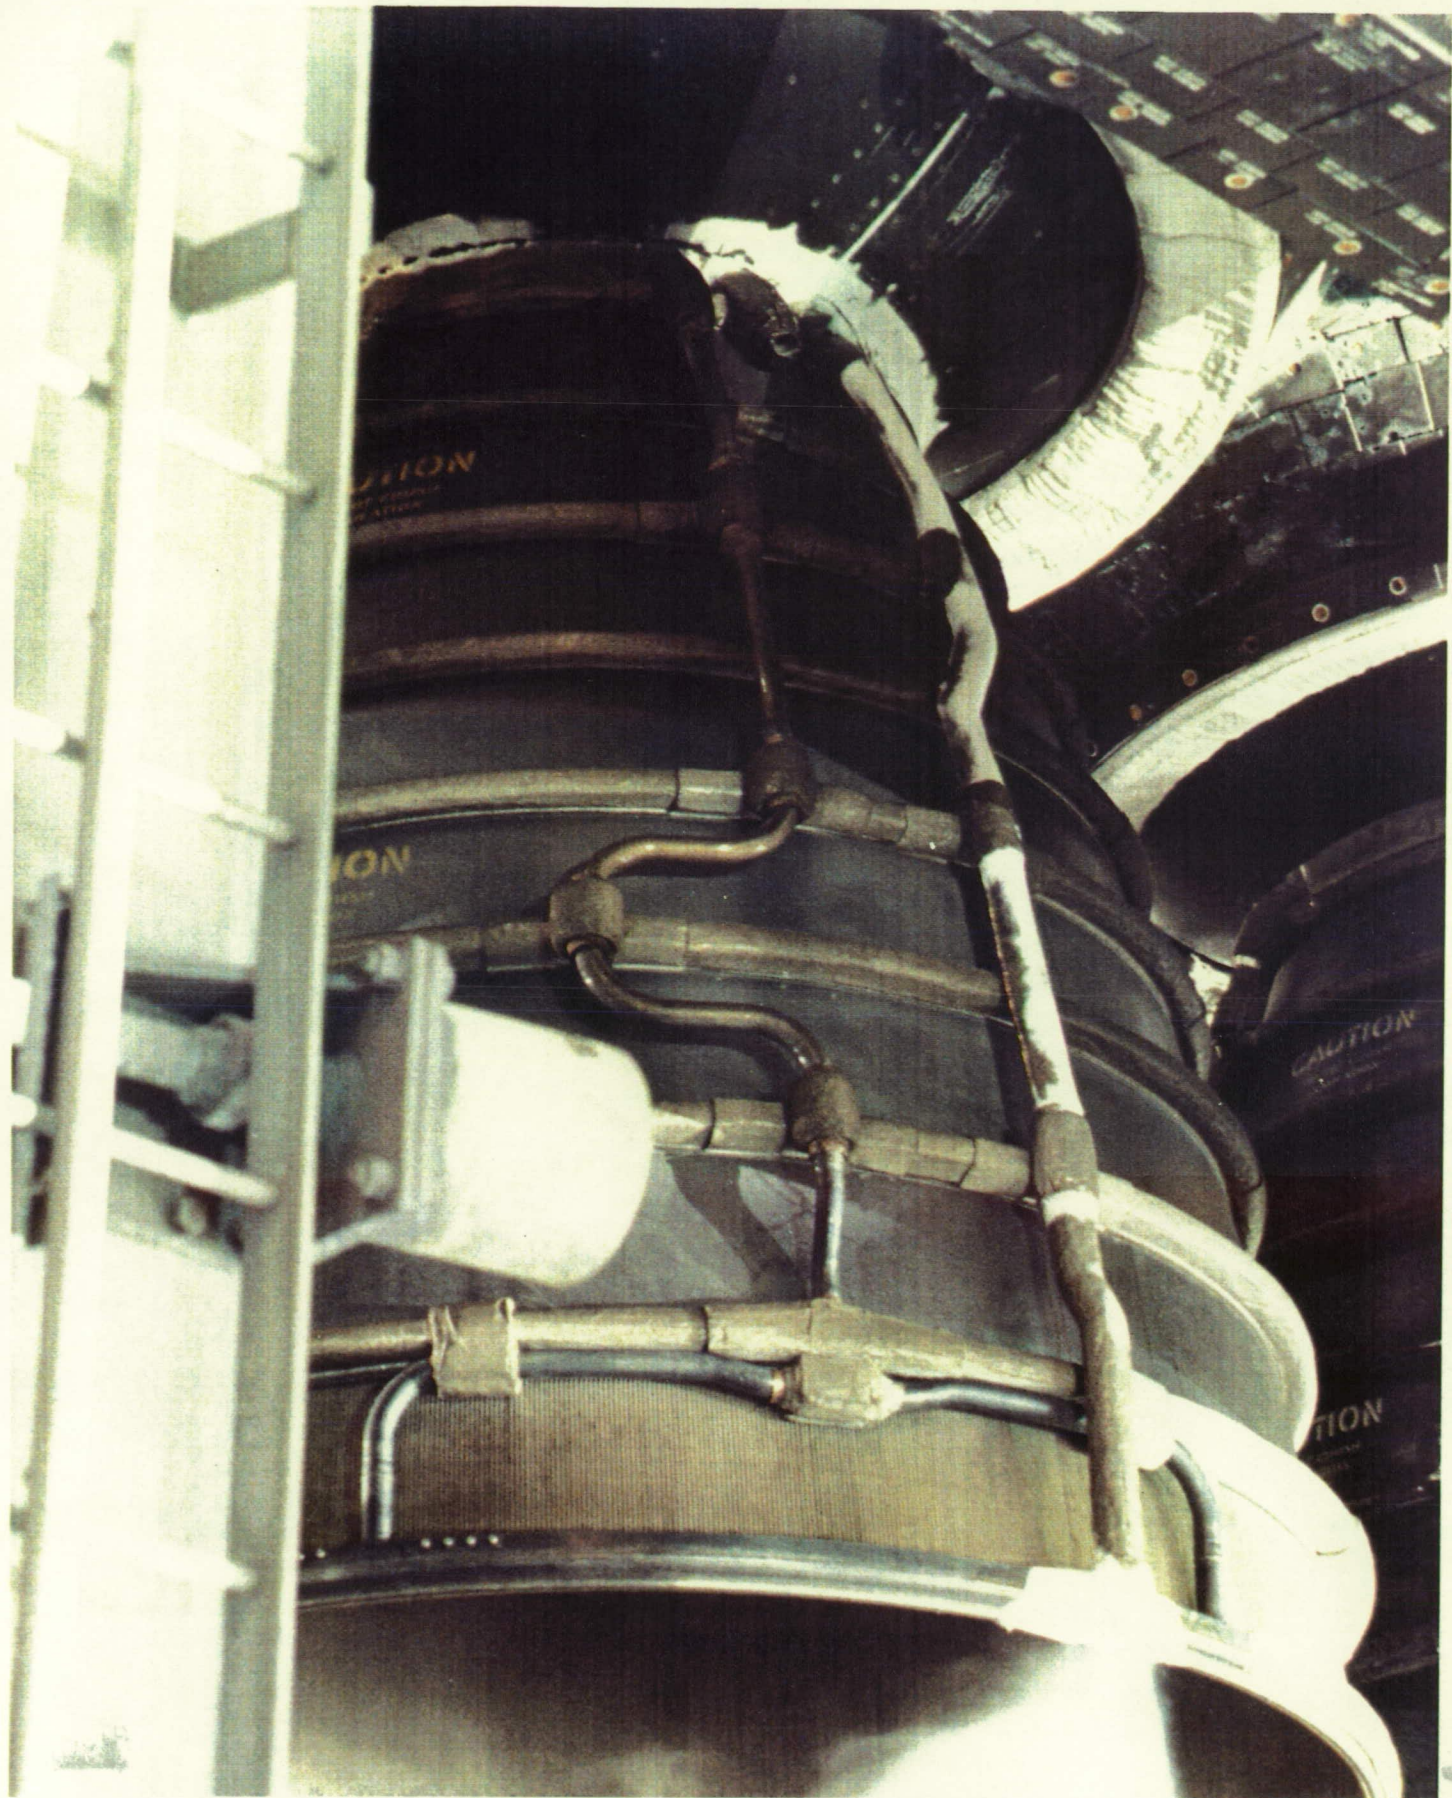
Frost coated the SSME #2 drain line and engine-mounted heat shield-to-nozzle interface along the full circumference. Some condensate was also present on the engine mounted heat shield.

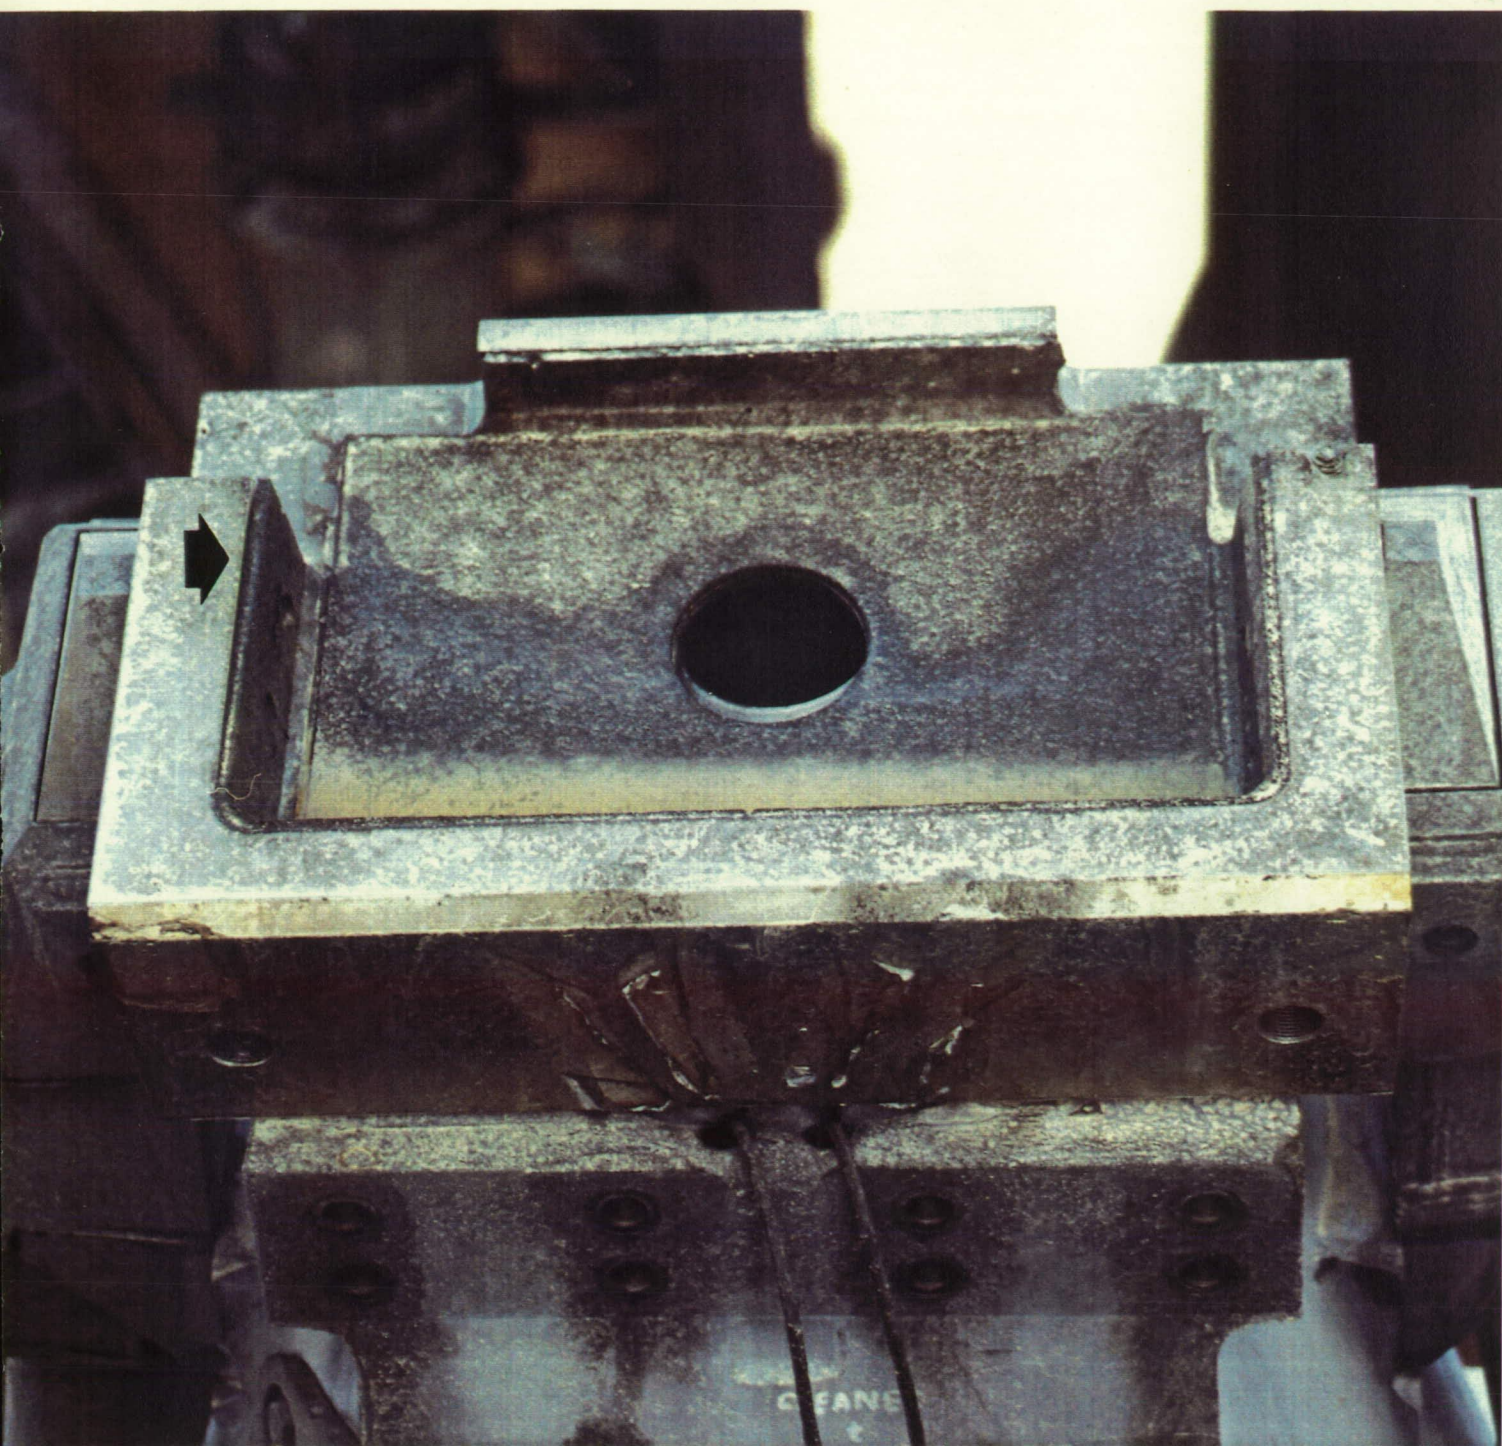
Plume erosion of the south SRB holddown posts was typical. EPON shim material was intact, but slightly debonded from the holddown post shoe sidewalls on HDP #1, #2, and #6. There was no visual indication of a stud hang-up on any of the south holddown posts.

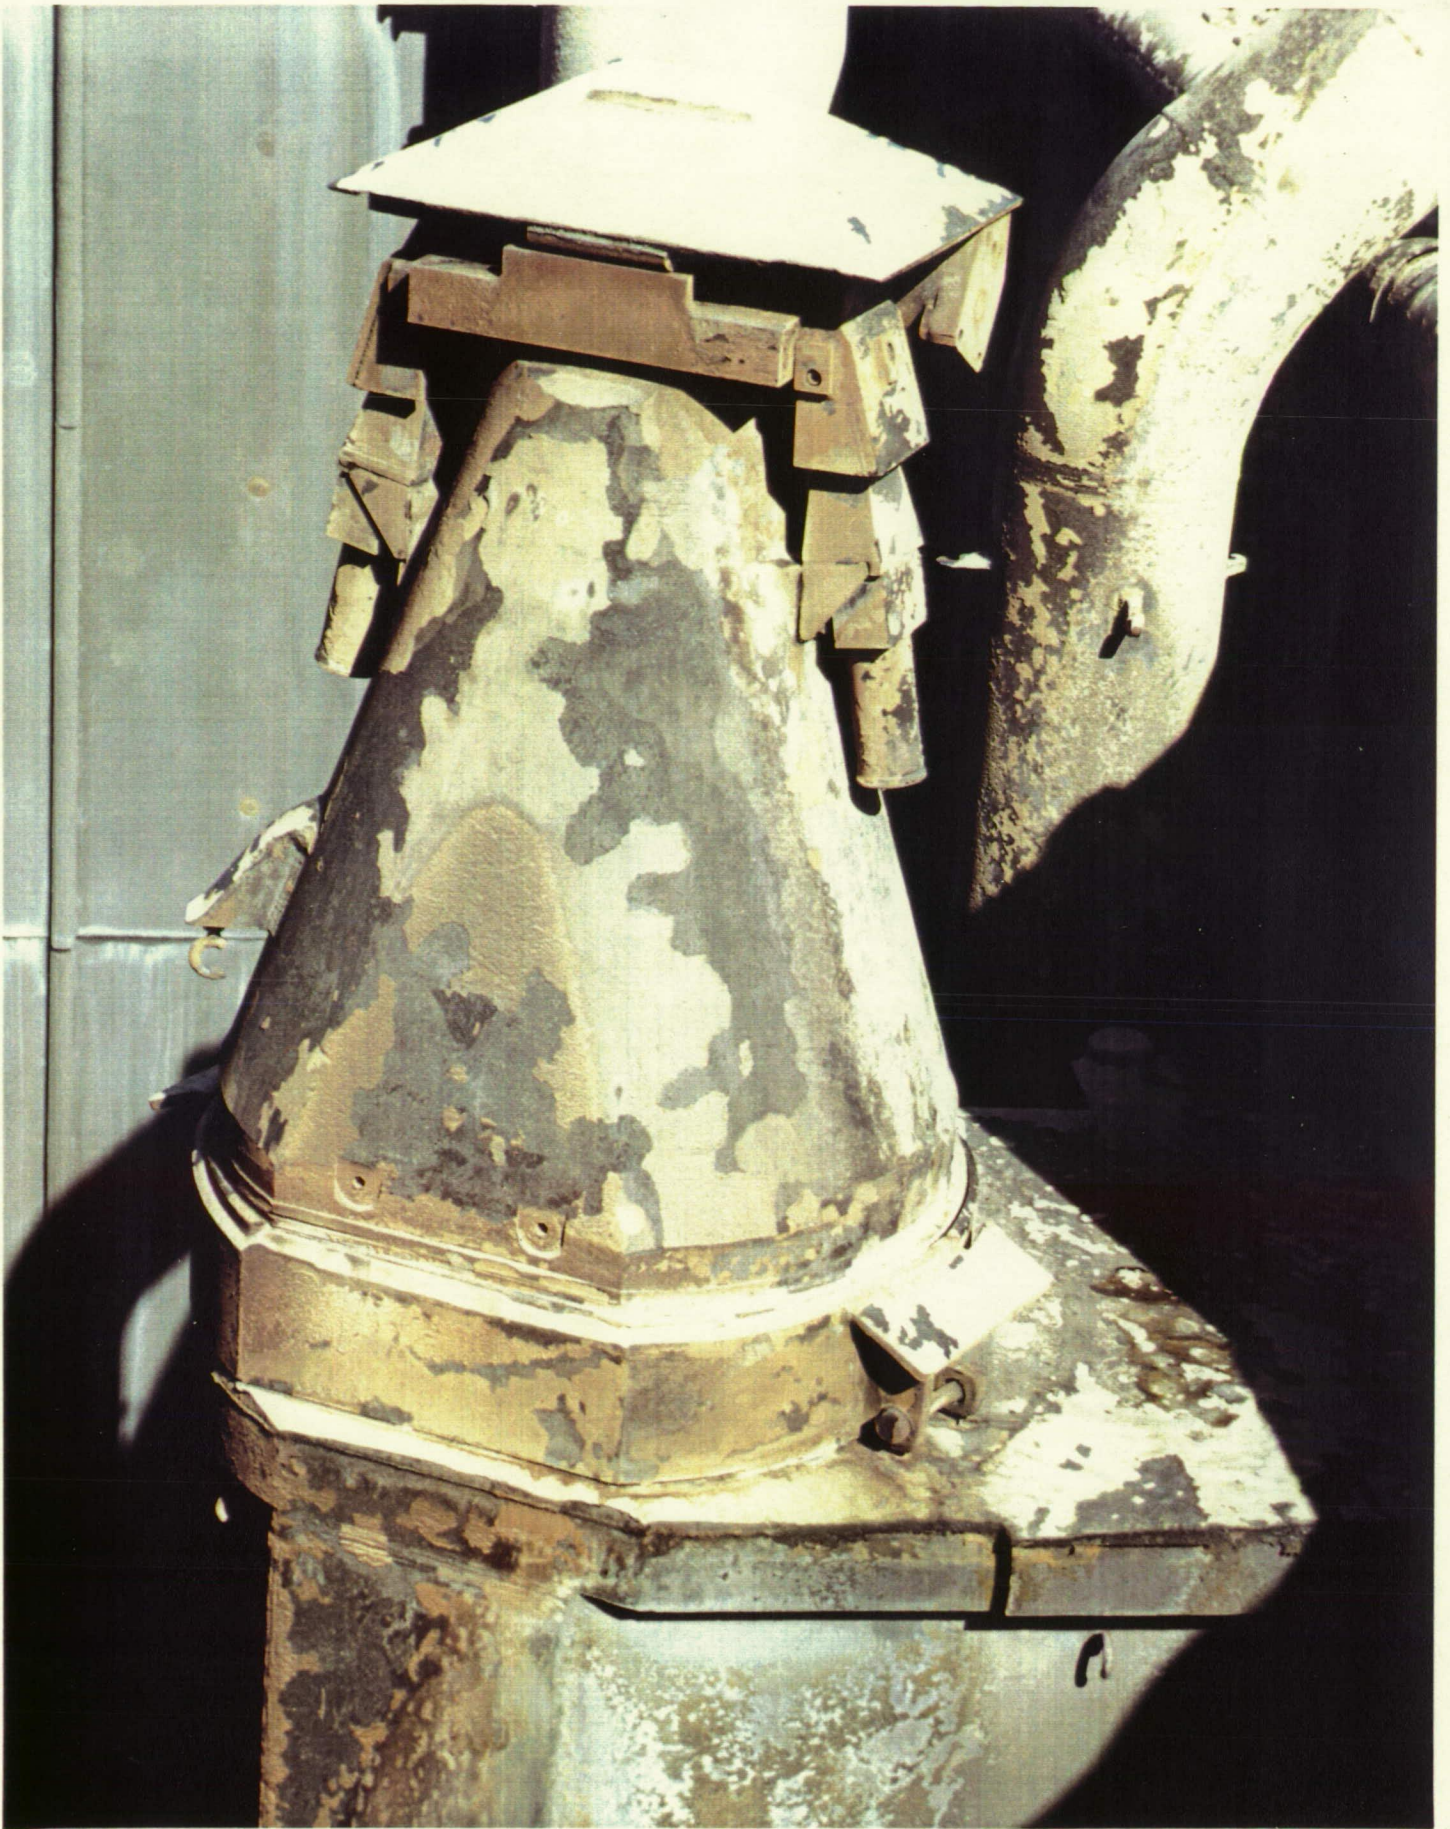
North HDP blast covers were in the closed position and exhibited typical SRB plume erosion effects

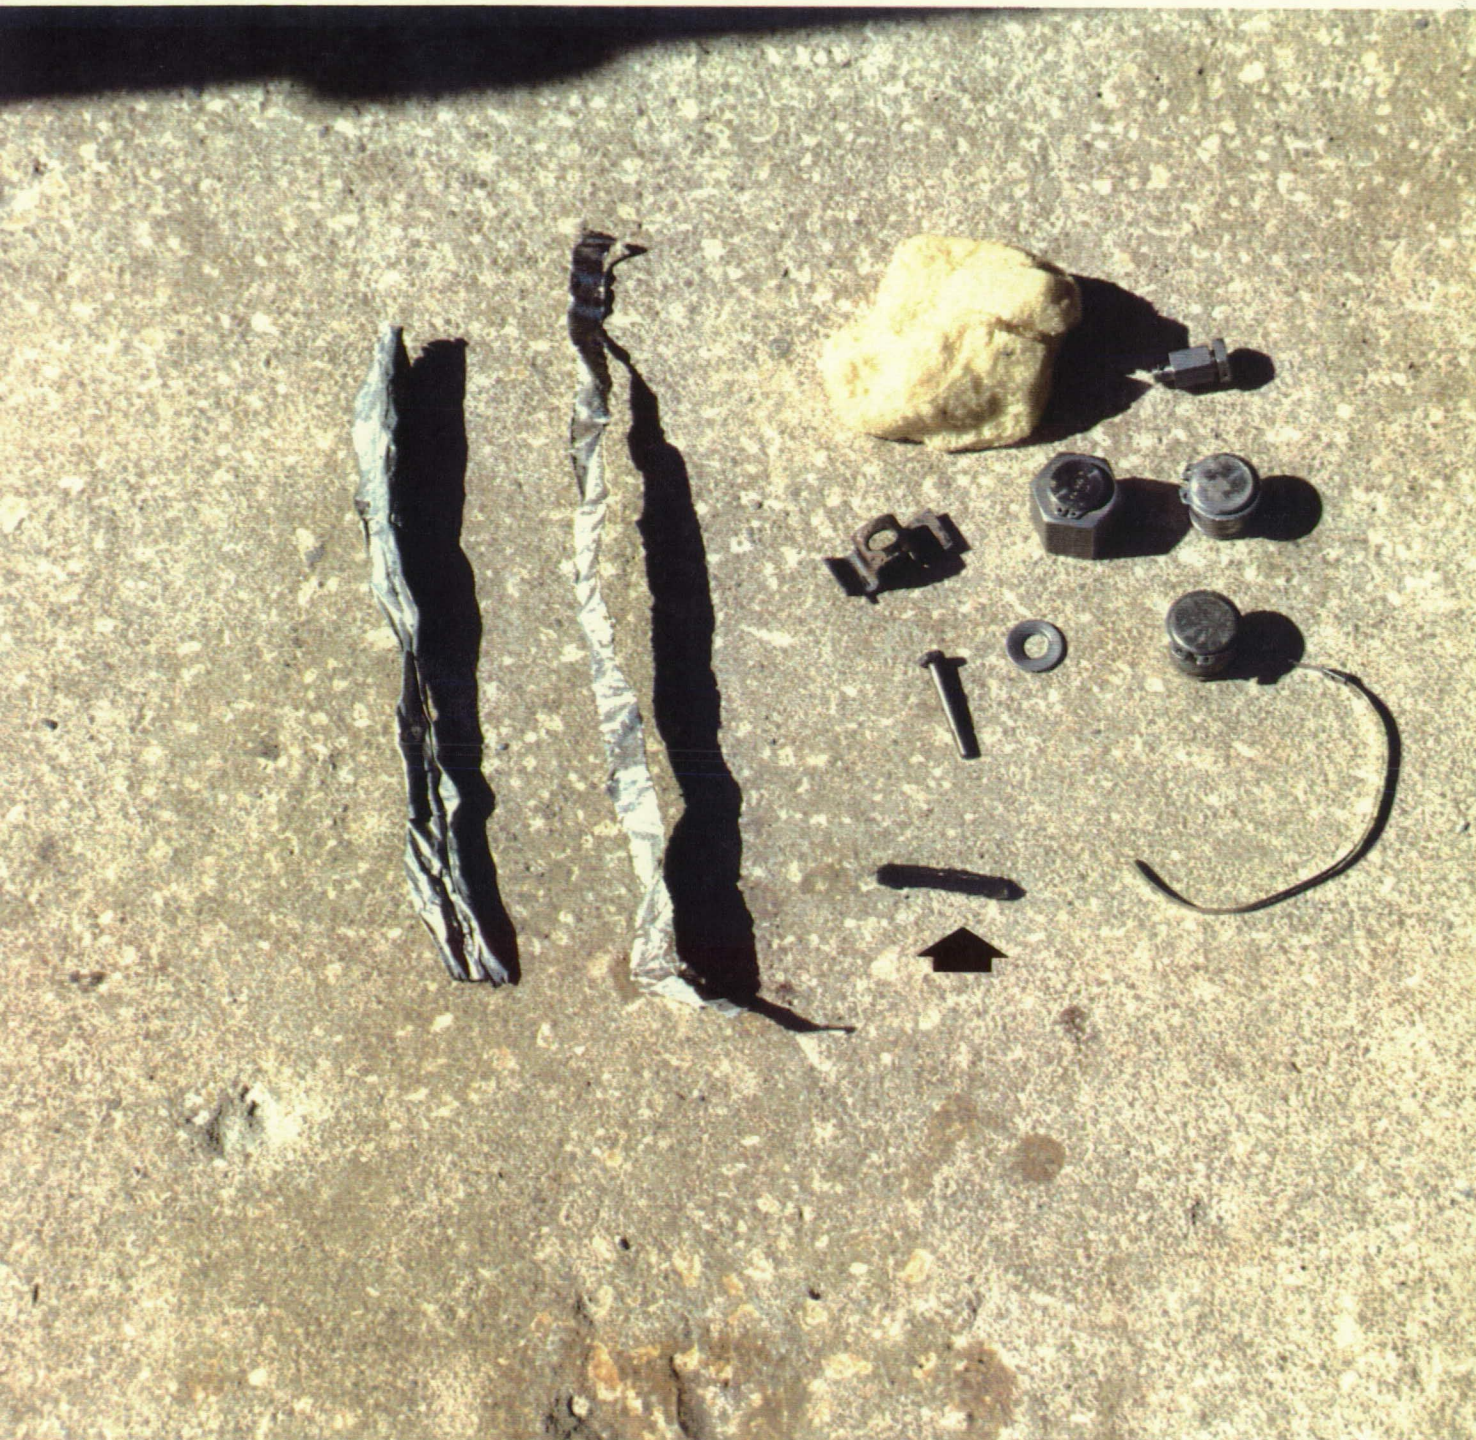
Typical post launch debris included SRB holddown post frangible nut web (2.0x0.25 inches), SRB throat plug material, facility bolts and hardware, pneumatic line caps/covers, and strips of insulation.

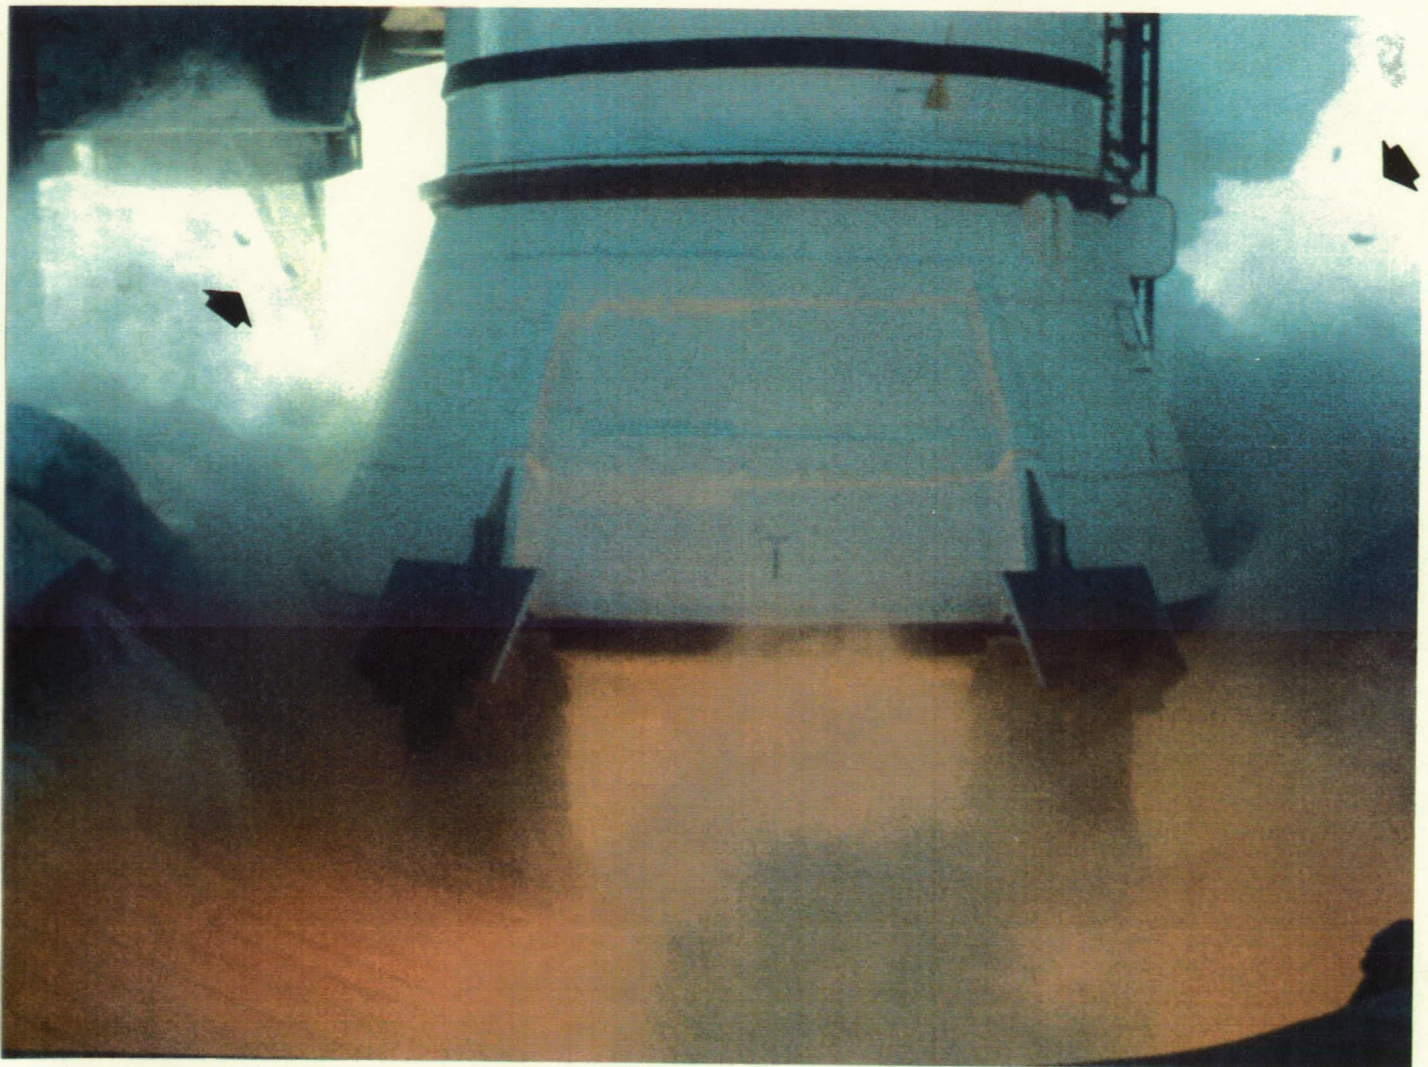
Thin, flexible, light-colored objects appeared out of the SRB exhaust holes/holddown post haunch areas after T-0 and were identified as cloth part tags attached to the sound suppression water troughs (Film item E-16)

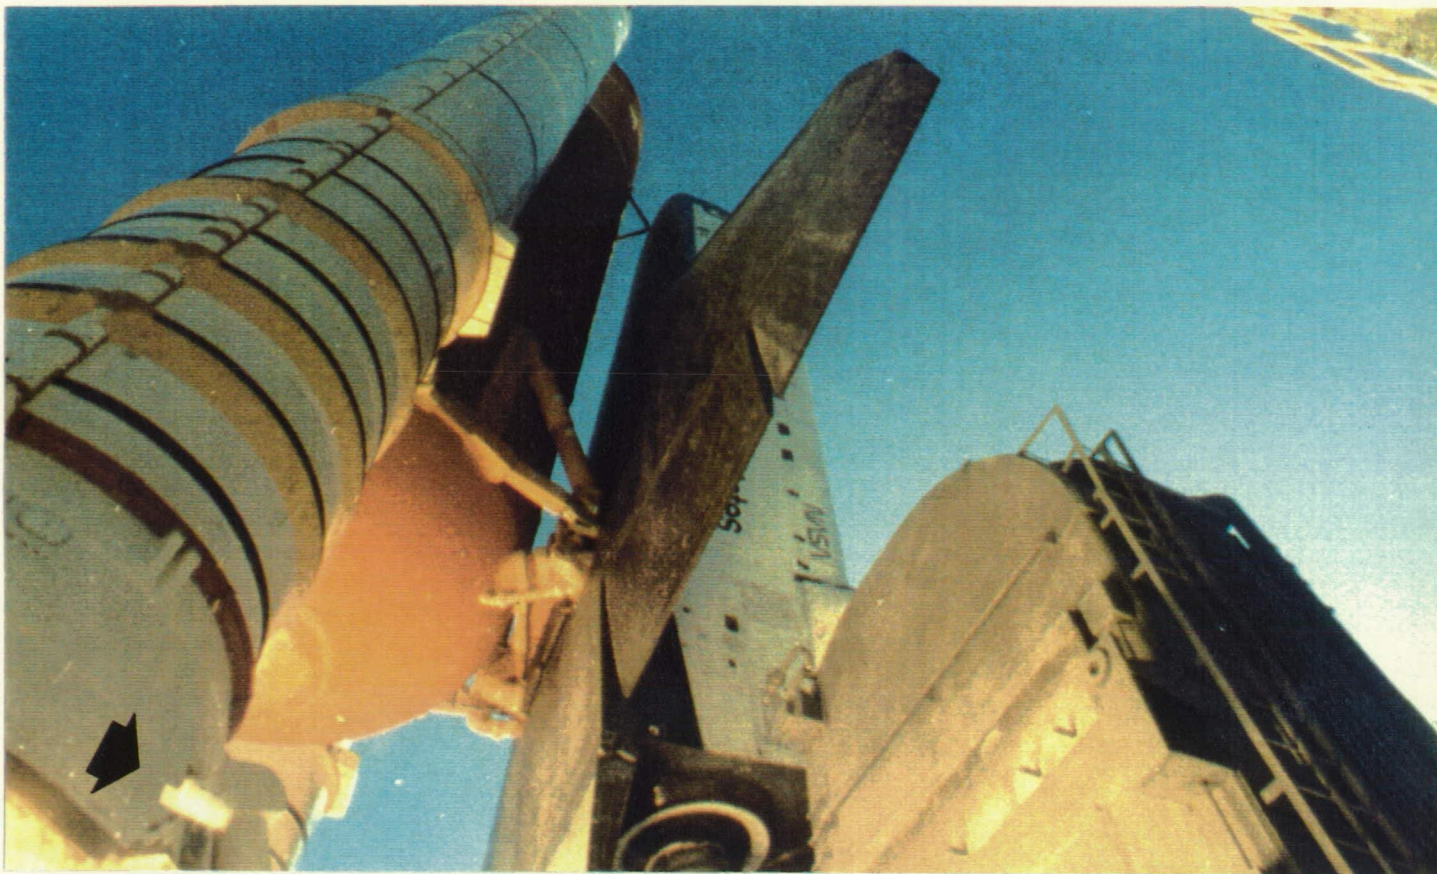
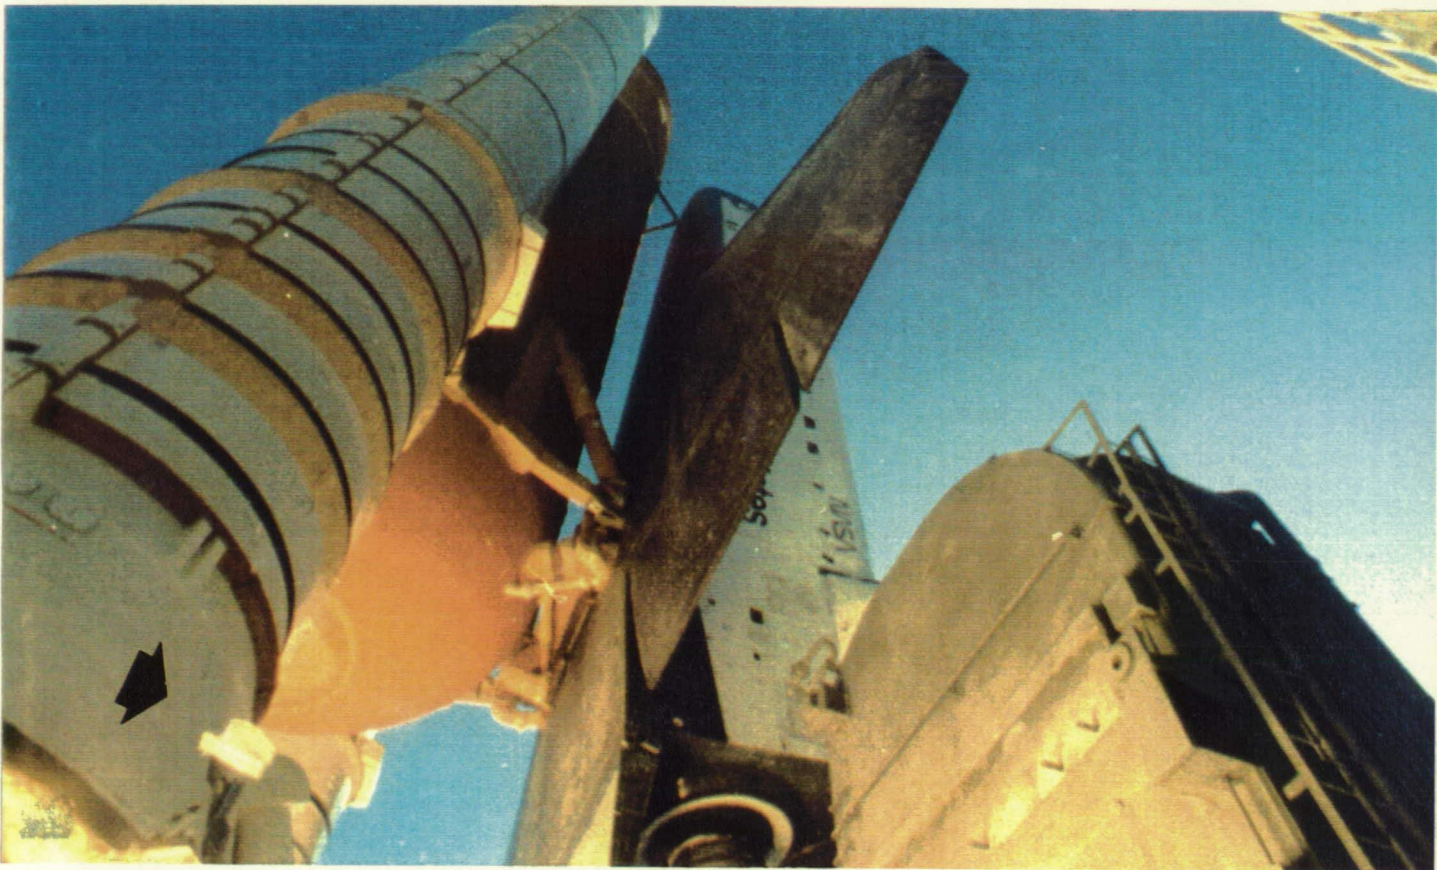
Thin, light-colored object with straight edges in this film item E-26 view may be one of the cloth part tags from the SRB sound suppression water troughs that were visible in film E-16.

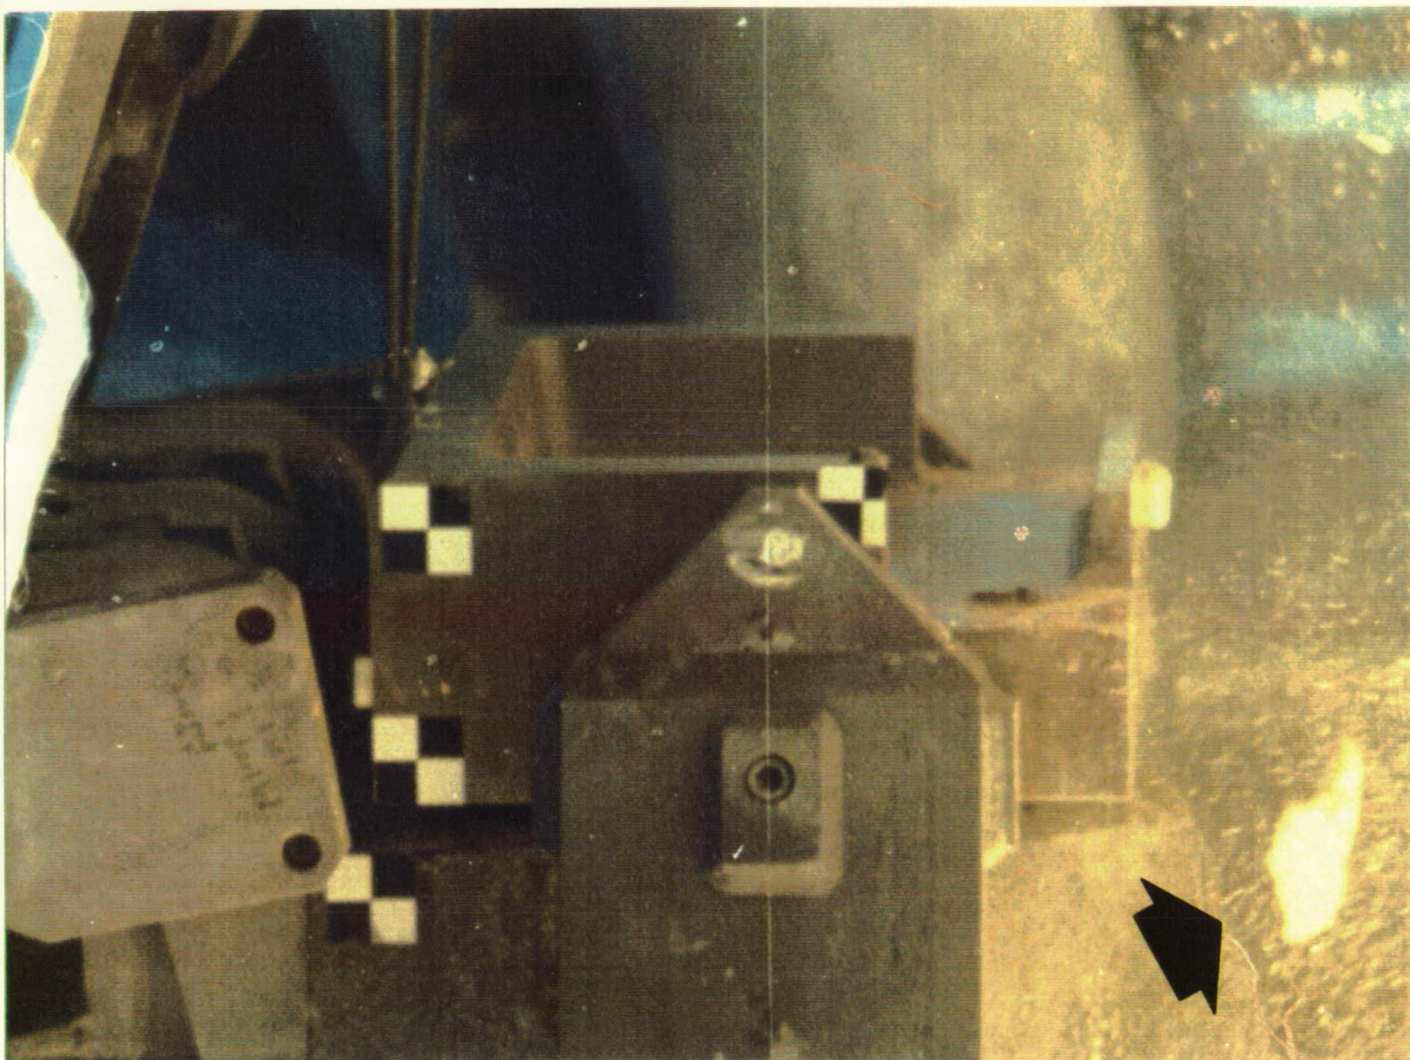
Film item E-28 showed a piece of instafoam breaking loose after liftoff from the LH SRB aft skirt near Holddown Post #7.

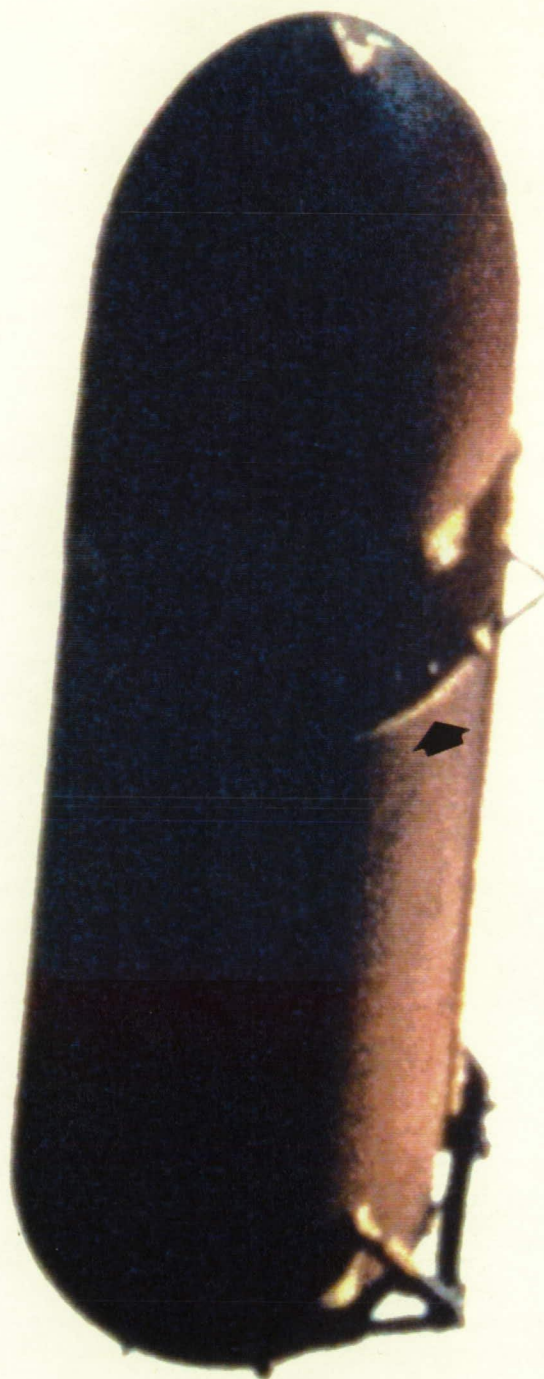
Two light spots in the intertank -Y+Z quadrant acreage outboard of the -Y bipod ramp and forward of the intertank-to-LH2 tank flange closeout appeared to be possible divots 8-12 inches in diameter. No anomalies were visible on the nosecone or L02/LH2 tank acreage areas.

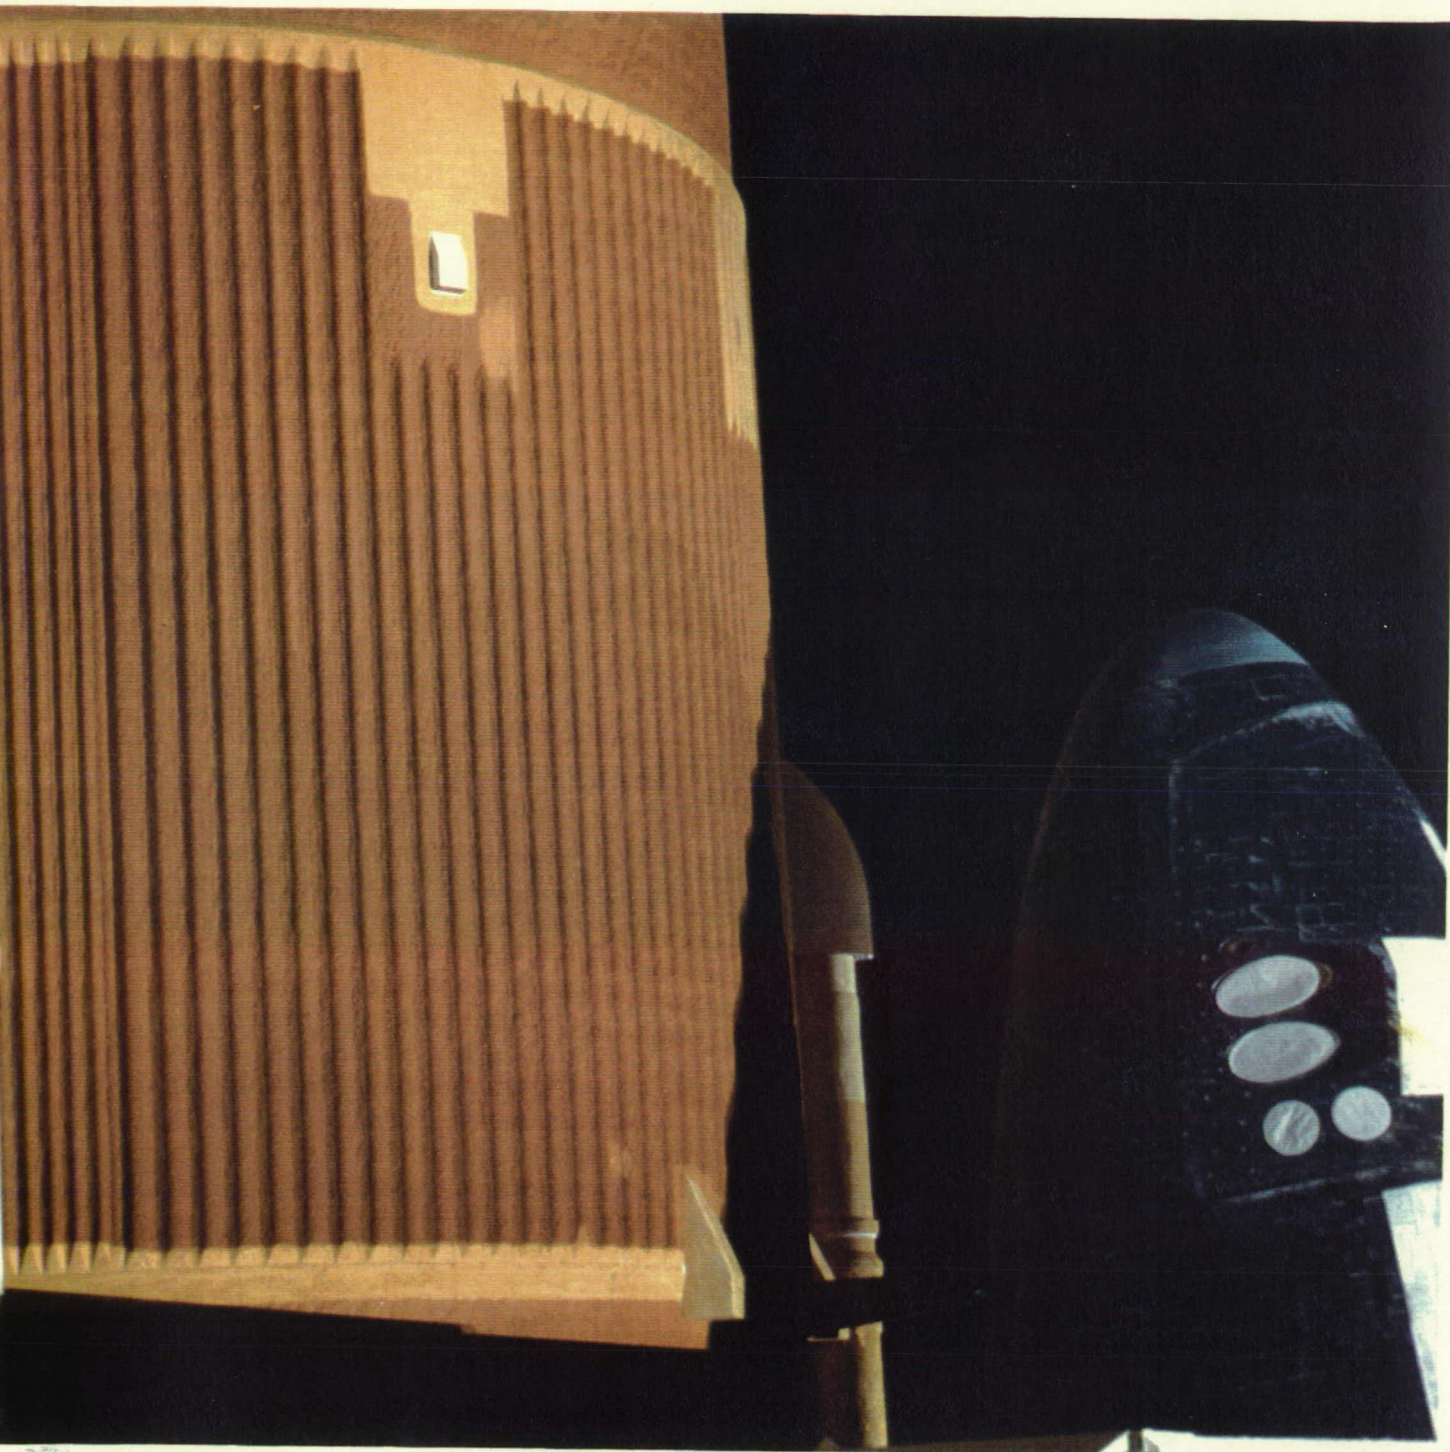
View of External Tank -Y+Z quadrant showed no intertank TPS acreage anomalies after the vehicle had been cryoload that would account for the divots observed in the on-orbit photos.
